JUNE 1983 THE NAVAL AVIATION SAFETY REVIEW

In this issue:
★ Lightning and Naval Aviation
★ Elmo, Patron Saint of Night
★ Weight and Balance Features

LIGHTNING

Weight, Balance, Power Available — Do They All Add Up?

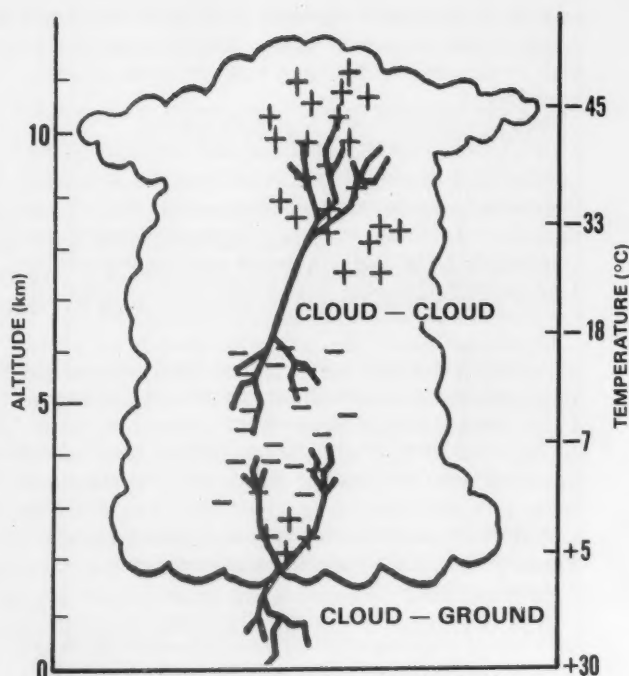
Fig. 1 Distribution of charge in a thundercloud.

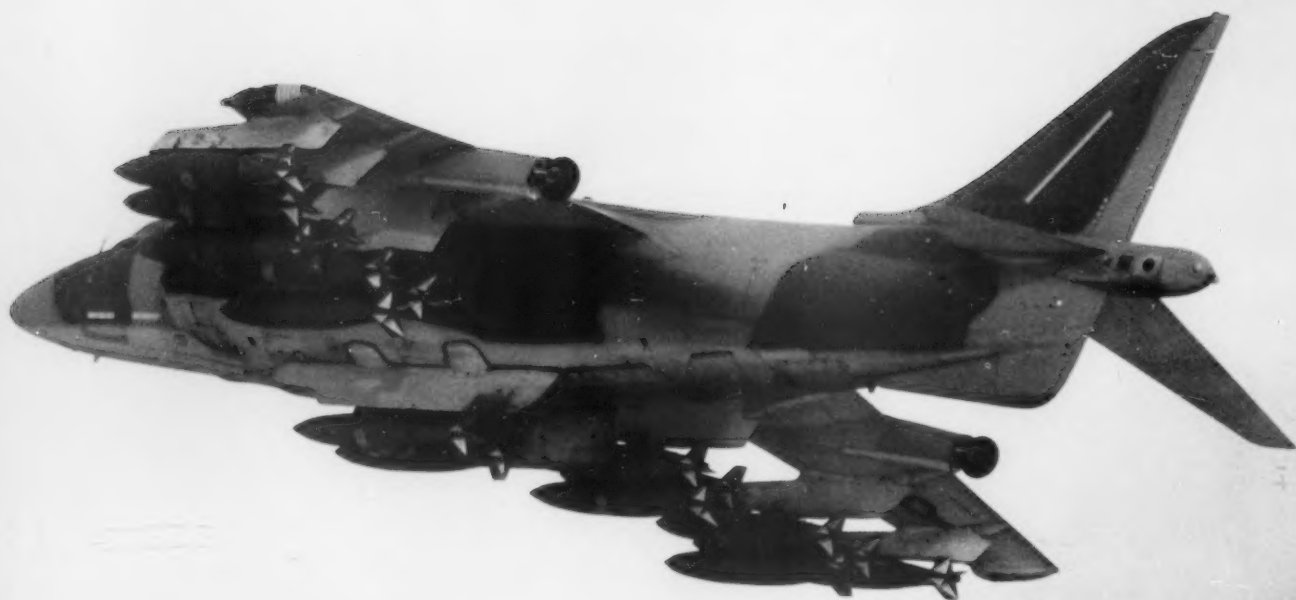
McDonnell-Douglas

The AV-8B Harrier II will begin replacing the AV-8A this November when the first of 12 pilot production models is delivered to VMAT-203 at MCAS Cherry Point, N. C. The "B" is an evolutionary improvement over the "A," and in our November '83 issue, we'll be discussing technological advancements in the Harrier II that significantly increase readiness, performance and safety.
